Intel[®] Mobile Pentium[®] II Processor Specification Update

Release Date: April 2000

Order Number: 243887-020

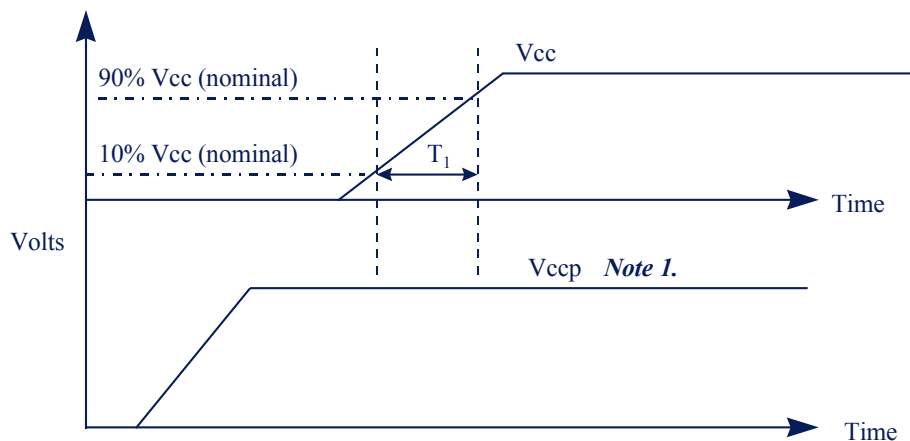
Problem: The processor uses the PWRGOOD signal to ensure that no voltage sequencing issues arise; no pin assertions should cause the processor to change its behavior until this signal is asserted, when all power supplies and clocks to the processor are valid and stable. However, if V_{CC} ramps up before V_{CCP} , it will cause the processor to enter an invalid state.

Implication: If this erratum occurs, the system may boot normally however, the L2 cache may not be initialized.

Workaround: For Mobile Pentium II processors, ensure that V_{CC} ramps after or with the L2 cache IO voltage (V_{CCP}). If V_{CCP} ramps after the V_{CC} , a delay circuit can be placed on the core V_{CC} to ensure that V_{CC} ramps at the same time or after V_{CCP} as shown below in Figure 1.

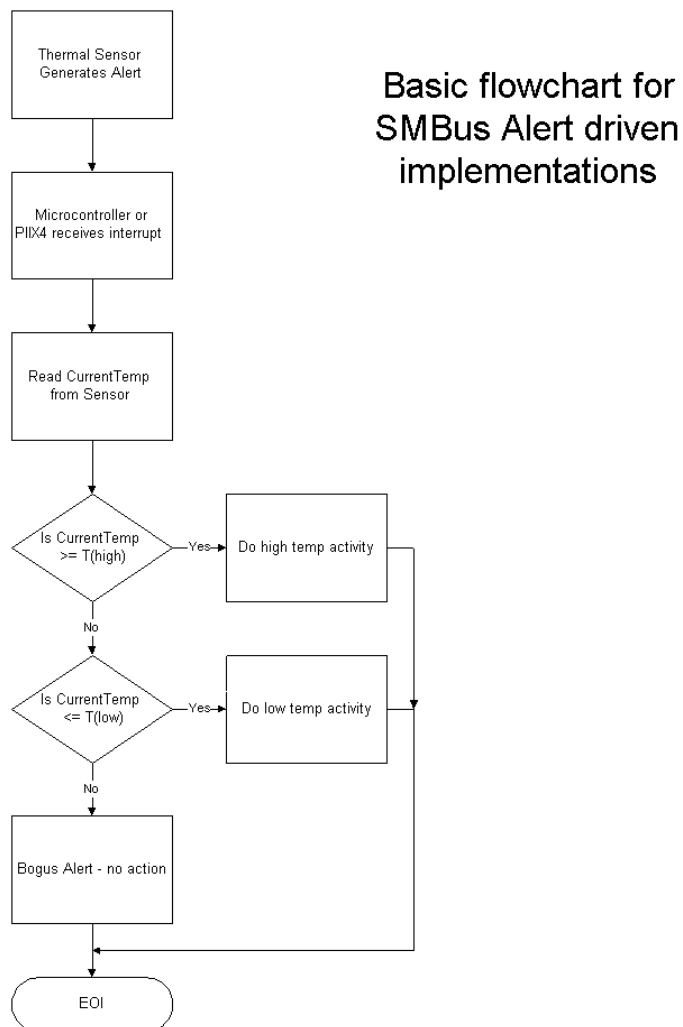
Figure 2. Workaround Flowchart: SMBALERT#-Driven System

Under the conditions described below, the thermal sensor incorrectly generates the SMBALERT# interrupt. All of the following conditions must be met to trigger a false interrupt:

1. Before servicing an interrupt from the thermal sensor, read and compare the processor thermal reading with the threshold limits (T_{HIGH} or T_{LOW}). Figures 2 and 3 provide basic flowcharts for the implementation of this workaround in an interrupt driven system.
2. If the firmware implemented polls the Status Register only, then before taking any action, re-read the temperature register and do a comparison with the alarm threshold limits (T_{HIGH} or T_{LOW}) to determine if the value is actually still within the temperature window.

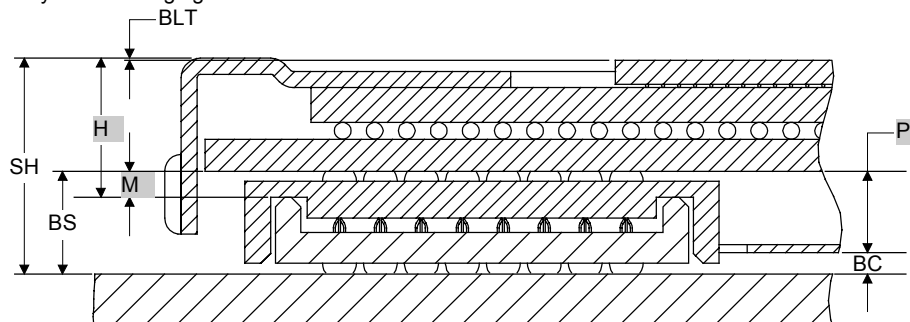
Figure 5.6. Cross Sectional View with Vertical Dimensions

B1. Misabeled Vertical Dimension Parameters

Figure 5.6 in the *Mobile Pentium® II Processor at 233 MHz, 266 MHz, and 300 MHz* datasheet should be replaced by the following figure:

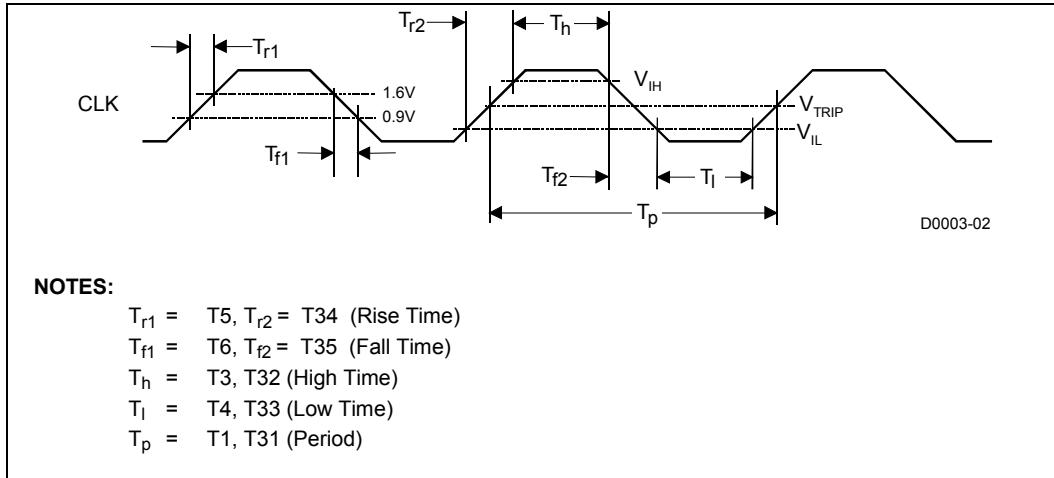
Figure 3.3 Generic Clock Waveform

B14. Generic Clock Waveform Figure

Figure 3.3 in *Mobile Pentium® II Processor in Mini-Cartridge Package at 366 MHz, 333 MHz, 300PE MHz, and 266PE MHz* datasheet (Order Number 245108), and the *Mobile Pentium® II Processor in BGA Package at 366 MHz, 333 MHz, 300PE MHz, and 266PE MHz* datasheet (Order Number 245106) has been updated. The following figure is to replace the ones in the above documents.
